# Inspection Report

**Property Address:**

4015 SE 20th PI Unit 301

Cape Coral FL 33904

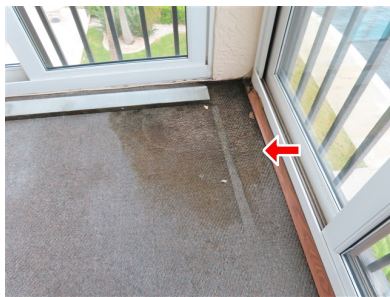
1.0 Item 1 (Picture)

(1) Carpet at enclosed porch exhibited signs of staining from past moisture intrusion.

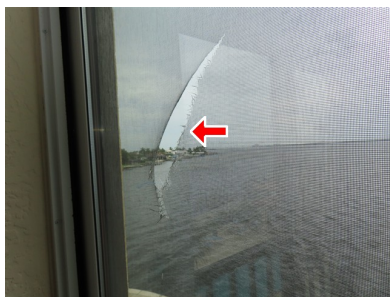
1.0 Item 2 (Picture)

(2) Damaged screening at enclosed porch should be replaced by a qualified contractor.

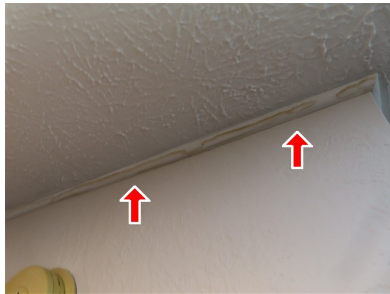
**2.2 Item 1 (Picture)**

Stains on the ceiling in the entry way appeared to be the result of moisture intrusion from roof leakage. The moisture meter showed no elevated levels of moisture present in the stained areas at the time of the inspection, indicating that the source of moisture may have been corrected, or leakage may be intermittent. You should ask the seller about this condition. Before the expiration of your Inspection Objection Deadline you may wish to consult with a qualified contractor to discuss options and costs for re-painting the ceiling.

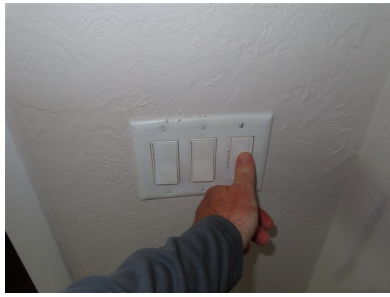
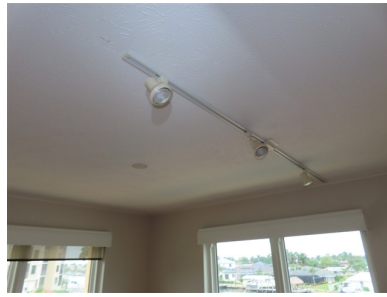
**2.3 Item 1 (Picture)**

A ceiling light fixture in the 1st shared bedroom did not respond to the switch. The bulb may need to be replaced or there may be a problem with the switch, wiring or light fixture. If after the bulb is replaced this light still fails to respond to the switch, this condition may represent a potential fire hazard and the Inspector recommends that an evaluation and any necessary repairs be performed by a qualified electrical contractor.

A ceiling light fixture in the 1st shared bedroom did not respond to the switch. The bulb may need to be replaced or there may be a problem with the switch, wiring or light fixture. If after the bulb is replaced this light still fails to respond to the switch, this condition may represent a potential fire hazard and the Inspector recommends that an evaluation and any necessary repairs be performed by a qualified electrical contractor.

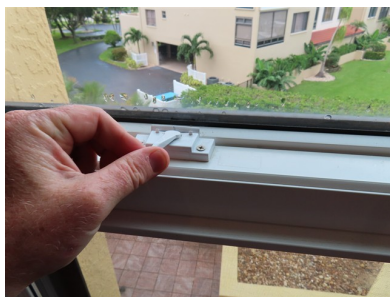
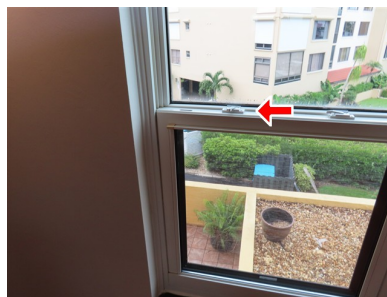
**2.7 Item 1 (Picture)**

(1) The locking hardware for a window by front door was difficult to operate. The Inspector recommends service by a qualified contractor.

(1) The locking hardware for a window by front door was difficult to operate. The Inspector recommends service by a qualified contractor.

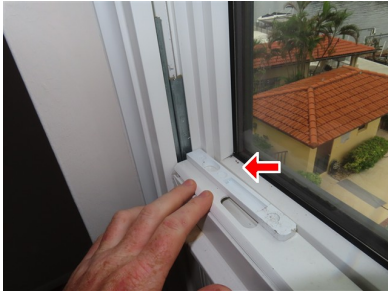
2.7 Item 3 (Picture)

(2) Locking mechanism of window in 1st shared bedroom is damaged. Repairs should be made by a qualified contractor.

(2) Locking mechanism of window in 1st shared bedroom is damaged. Repairs should be made by a qualified contractor.

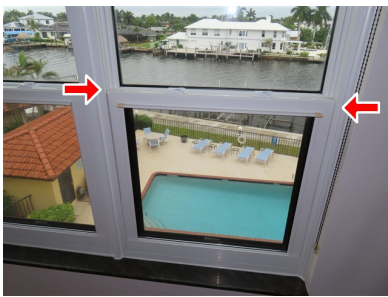
2.7 Item 4 (Picture)

(3) A sliding window in the 2nd shared bedroom was difficult to operate and needed maintenance. The Inspector recommends service by a qualified contractor.

(3) A sliding window in the 2nd shared bedroom was difficult to operate and needed maintenance. The Inspector recommends service by a qualified contractor.

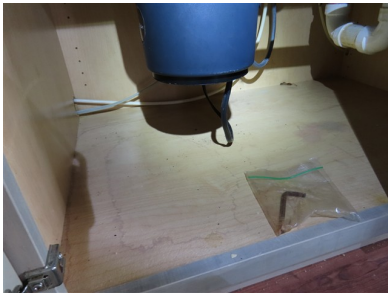
2.9 Item 2 (Picture)

(2) In the kitchen, the undersink cabinet floor had minor damage which appeared to be the result of past leakage. The moisture meter showed no elevated levels of moisture present in the cabinet floor at the time of the inspection indicating that the source of leakage may have been corrected.

(2) In the kitchen, the undersink cabinet floor had minor damage which appeared to be the result of past leakage. The moisture meter showed no elevated levels of moisture present in the cabinet floor at the time of the inspection indicating that the source of leakage may have been corrected.

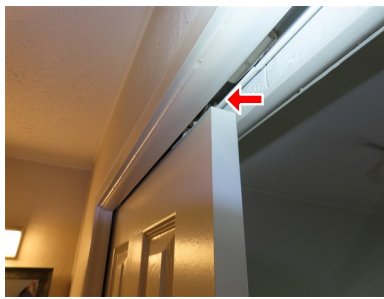
3.0 Item 1 (Picture)

A sliding door at master bathroom was difficult to operate. Rollers appear to be worn out or possibly needs adjusting. All work should be completed by a qualified contractor.

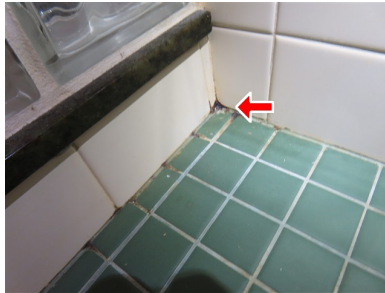
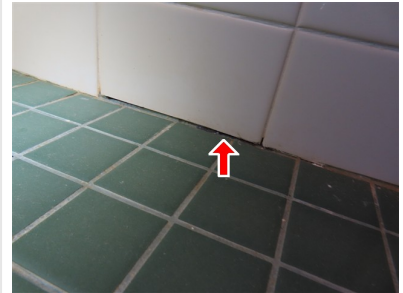
3.7 Item 1 (Picture)

(1) Grout maintenance needed at master bathroom shower.

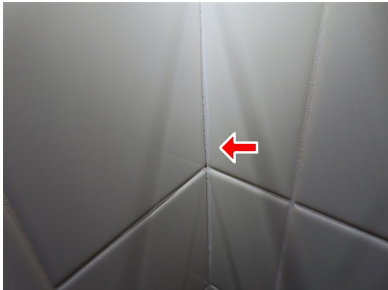
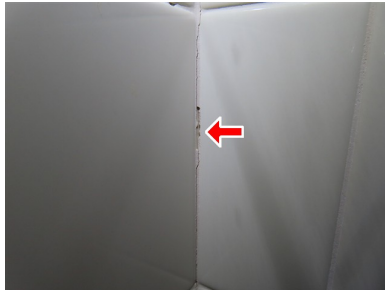
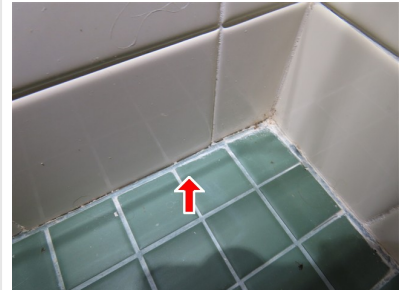
3.7 Item 4 (Picture)

(2) Grout maintenance needed at 1st shared bathroom shower.

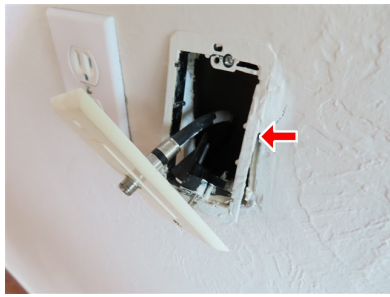
5.6 Item 1 (Picture)

(1) Cable outlet and cover in living room is damaged and needs replaced.

(1) Cable outlet and cover in living room is damaged and needs replaced.

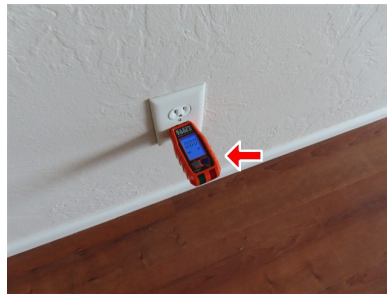
5.6 Item 2 (Picture)

(2) An electrical receptacle in the living room was inoperable. The Inspector recommends service by a qualified electrical contractor.

(2) An electrical receptacle in the living room was inoperable. The Inspector recommends service by a qualified electrical contractor.

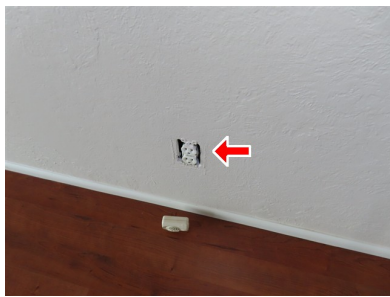
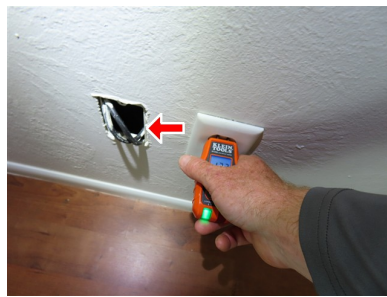
5.6 Item 4 (Picture)

(3) An electrical receptacle cover plate was missing in the master bedroom. This condition left energized electrical components exposed to touch, a shock/electrocution hazard. The Inspector recommends a cover plate be installed by a qualified electrical contractor.

(3) An electrical receptacle cover plate was missing in the master bedroom. This condition left energized electrical components exposed to touch, a shock/electrocution hazard. The Inspector recommends a cover plate be installed by a qualified electrical contractor.

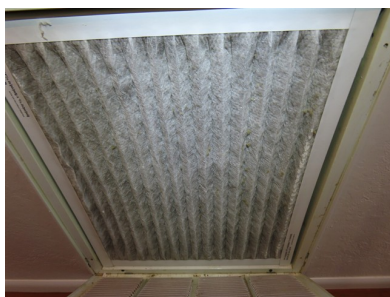
7.0 Item 1 (Picture)

The air filter for this furnace was dirty and should be changed. Filters should be checked every three months and replaced when they reach a condition in which accumulation of particles becomes so thick that particles may be blown loose from the filter and into indoor air. Homes in areas with high indoor levels of airborne pollen or dust may need to have air filters checked and changed more frequently. Failure to change the filter when needed may result in the following problems:

- reduced blower life due to dirt build-up on vanes, which increasing operating costs;
- reduced indoor air quality;
- increased resistance resulting in the filter being sucked into the blower;
- this condition can be a potential fire hazard;
- frost build-up on air-conditioner evaporator coils, resulting in reduced cooling efficiency and possible damage; and
- reduced air flow through the home.

The air filter for this furnace was dirty and should be changed. Filters should be checked every three months and replaced when they reach a condition in which accumulation of particles becomes so thick that particles may be blown loose from the filter and into indoor air. Homes in areas with high indoor levels of airborne pollen or dust may need to have air filters checked and changed more frequently. Failure to change the filter when needed may result in the following problems:

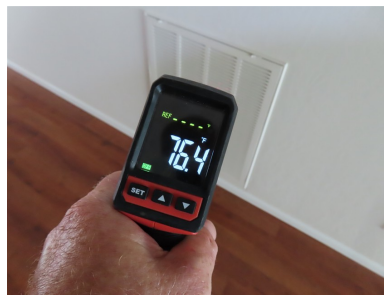
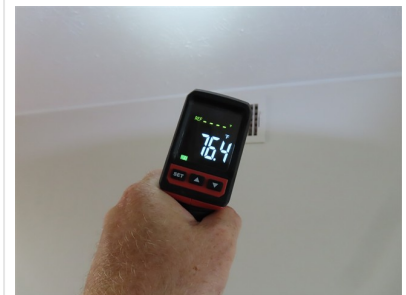
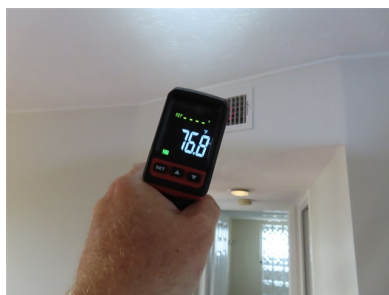
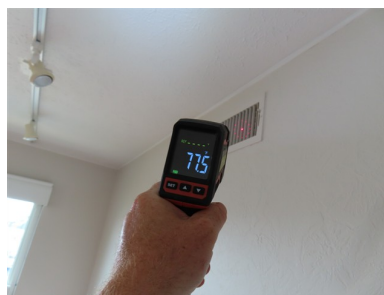
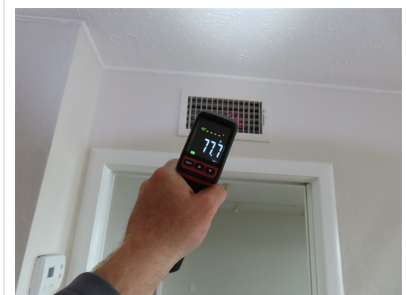
8.2 Item 1 (Picture)

The air-conditioning system did not respond to the thermostat and should be serviced by a qualified HVAC technician.

The air-conditioning system did not respond to the thermostat and should be serviced by a qualified HVAC technician.
